# **INDOOR AIR QUALITY ASSESSMENT**

## **Odor Investigation**

**Executive Office of Health and Human Services Center  
280 Merrimack Street  
Lawrence, Massachusetts**

Prepared by:  
Massachusetts Department of Public Health  
Bureau of Environmental Health  
Indoor Air Quality Program  
October 2017

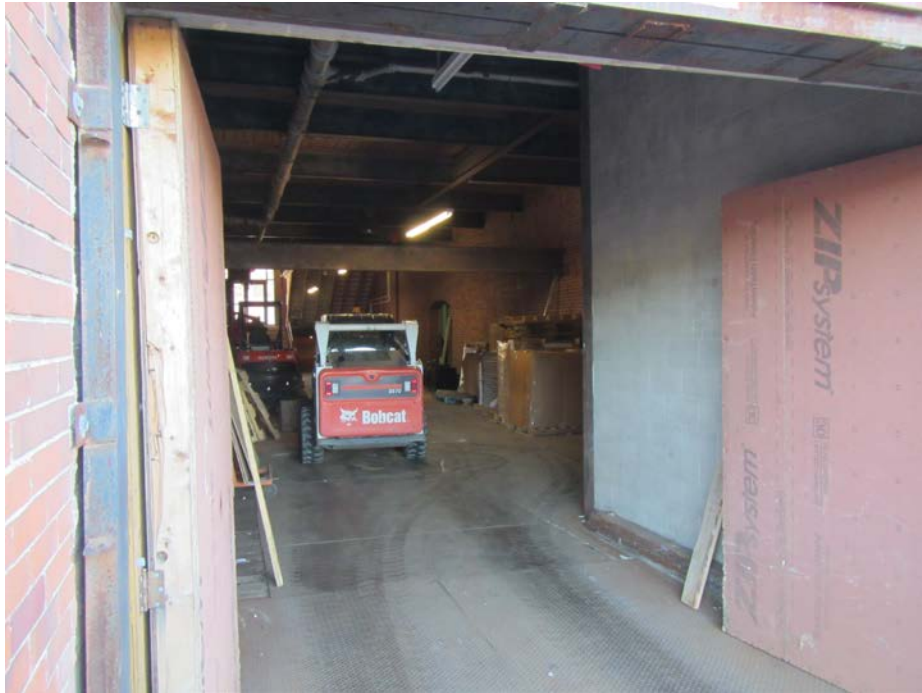
**Picture 1**

Ongoing construction was observed while performing an assessment of the building exterior. IAQ staff observed a large opening in the rear of the building as well as construction upwind and west of this facility and (Pictures 1 and 2). The building developer for 280 Merrimack Street, Lupoli Development, was interviewed by IAQ and EOHHS staff. During this interview, Lupoli representatives reported that work recently began on an abandoned, interior elevator shaft that runs the entire height of the building. This work coincided with the commencement of the odors. Contractors removed barriers which formerly covered many of the old elevator door openings (Picture 3). In addition, the contractors created an exterior access entrance in the rear of the building so construction equipment (excavators, bobcats, etc.) can be brought into the bottom of the elevator shaft area for excavation/construction (Picture 1).

**Large opening in rear of building (note construction vehicles inside)**

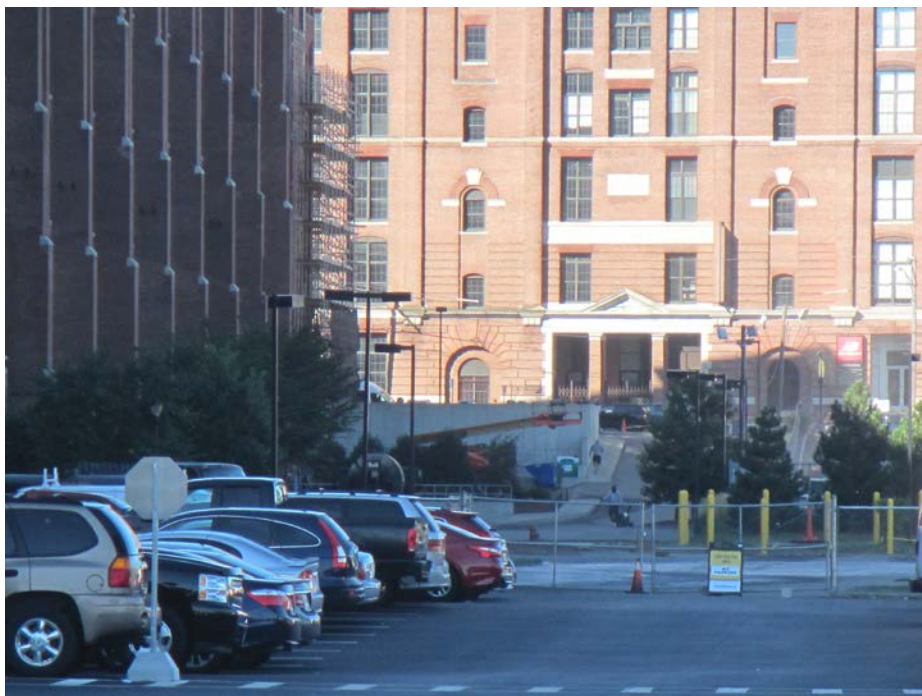
**Picture 2**

**Other construction activity in the area**

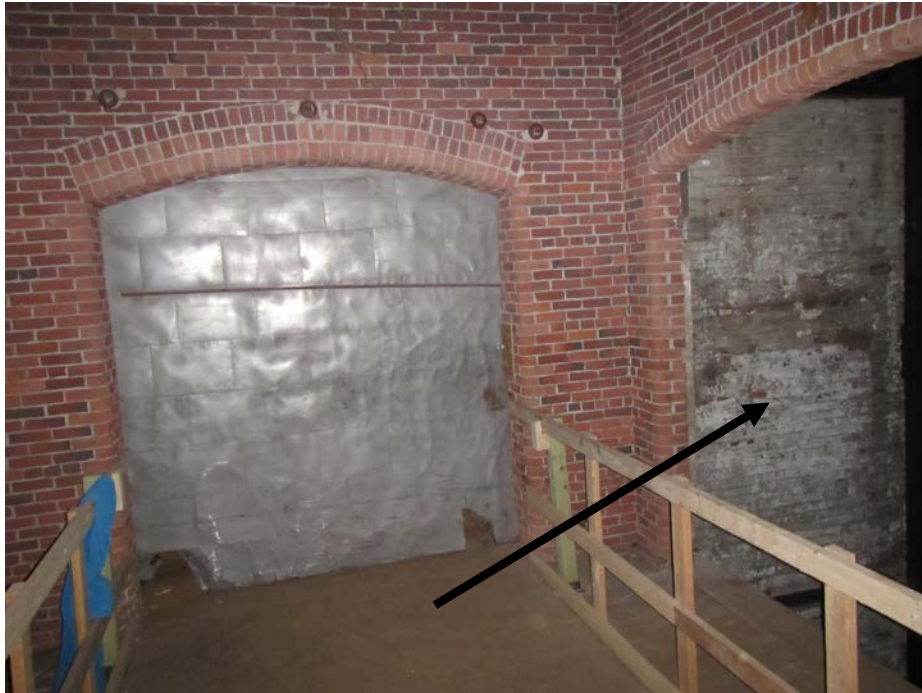
**Picture 3**

**Elevator shaft area showing door removed**

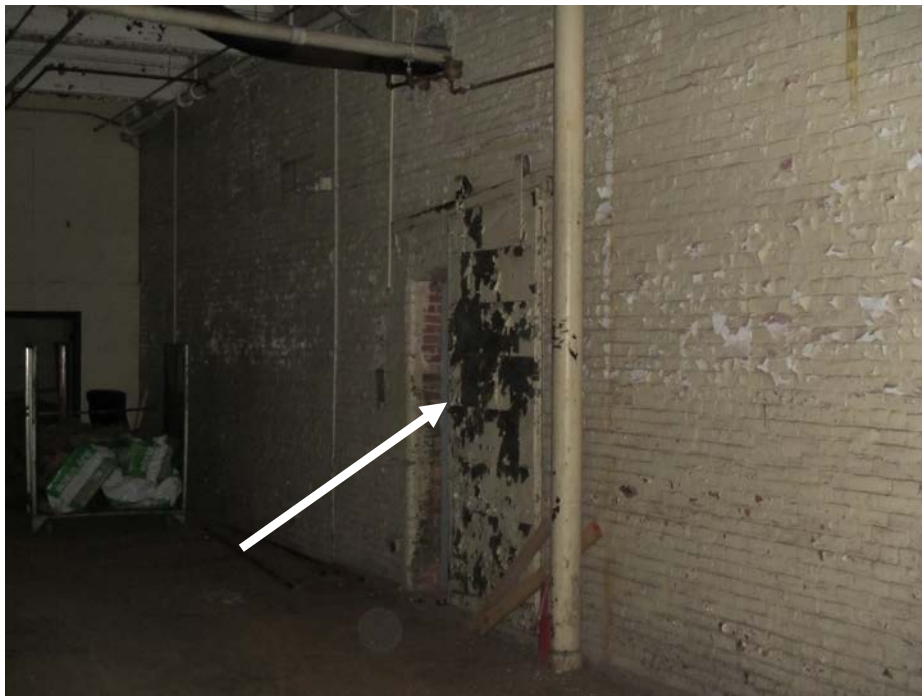
**Picture 4**

**Door leading from unconditioned area to occupied area**

3. Properly seal any other gaps or breaches in the shared walls/doors between occupant areas and unconditioned space (Pictures 4 and 5).
4. Continue to properly seal any holes/cracks/gaps in brick and mortar adjacent to abandoned elevator shaft (Picture 6) in DTA space.

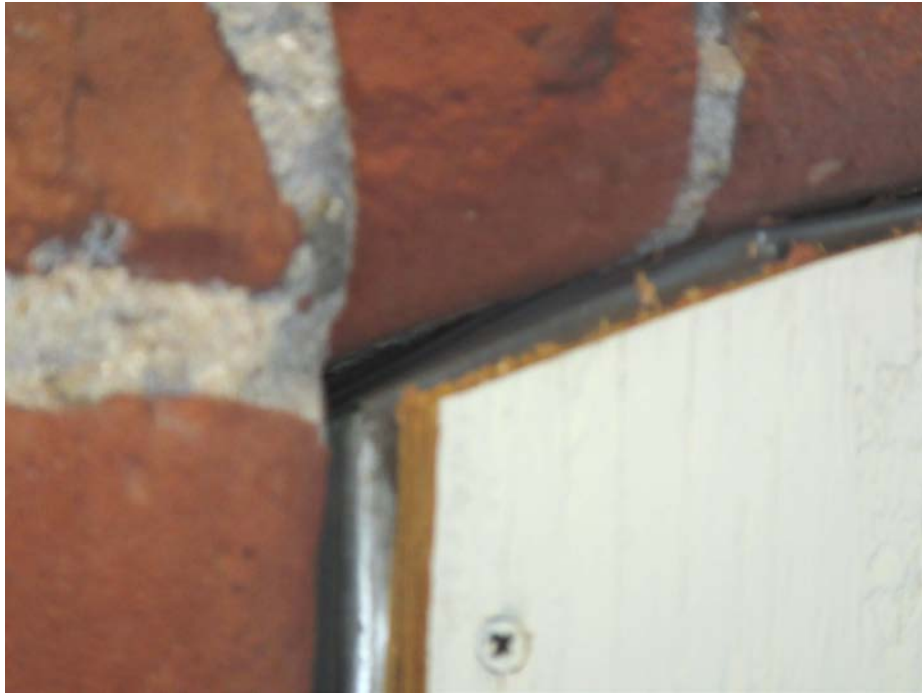
**Picture 5**

**Gaps in barrier between occupied and unconditioned area**

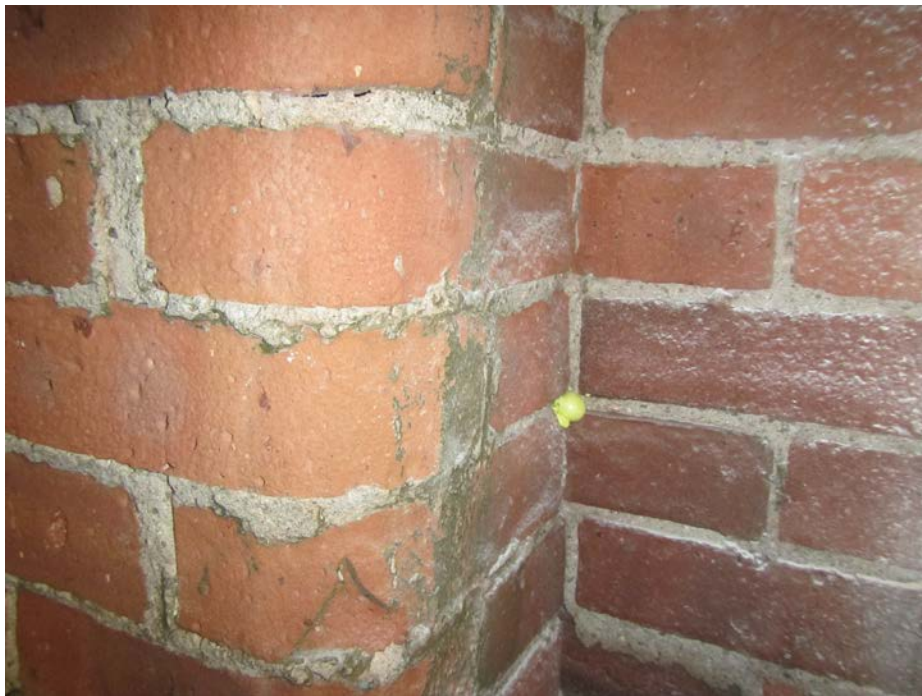
**Picture 6**

**Many cracks/holes were noted in brickwork adjacent to old elevator shaft**
